Radon Test

Bridgeport Campus  
17475 Bridgeport Rd.  
Dallas OR 97338

Luckiamute Valley Charter Schools  
12975 Kings Valley Hwy  
Monmouth OR 97361

Date: 01/20/2020      File name: LV13560  
Person ordering inspection: Daniel Shimek

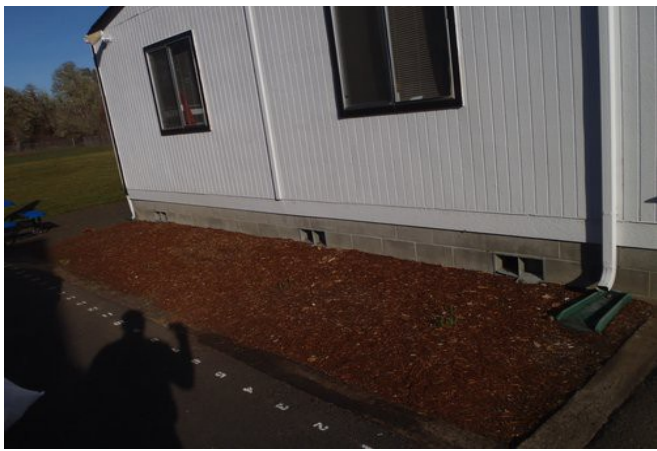
**Photo #124**

**4.2 Foundation Type, Modular Bldgs - Post Raised Open** The modular structures are constructed on a raised foundation with skirting around the perimeter. There is air space between the structure floors and the ground. The foundation vents were open at the start and/or end of the test; therefore, it is assumed that they were not maintained closed for the duration of the test period. (See Photo #124)

Structure Information - Foundation Type, Modular Bldgs

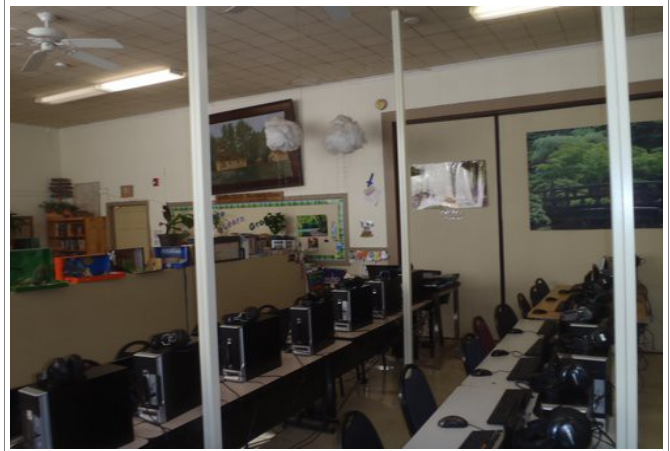
**Photo #102**

**5.2 Building Occupied During Test - Yes** The structure was in operational mode during testing and actively occupied prior to the testing period. Testing was completed during a time when students were not in the building to help limit the potential for tampering with testing devices. Management was instructed to maintain the structure consistent with placement conditions for the testing period. (See Photo #102 104 113)

Testing Conditions - Building Occupied During Test

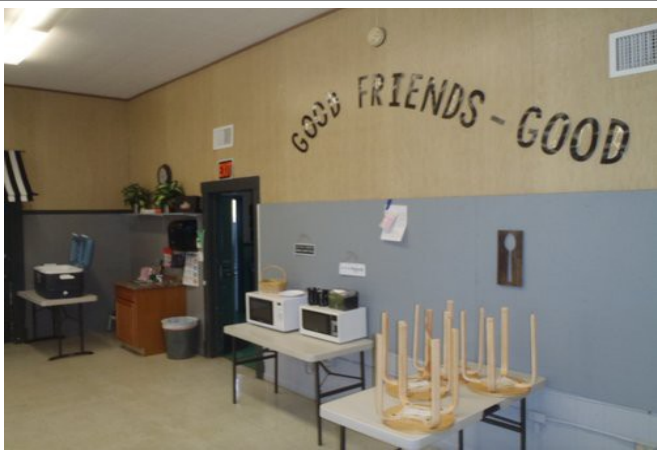
**Photo #104**

Testing Conditions - Building Occupied During Test

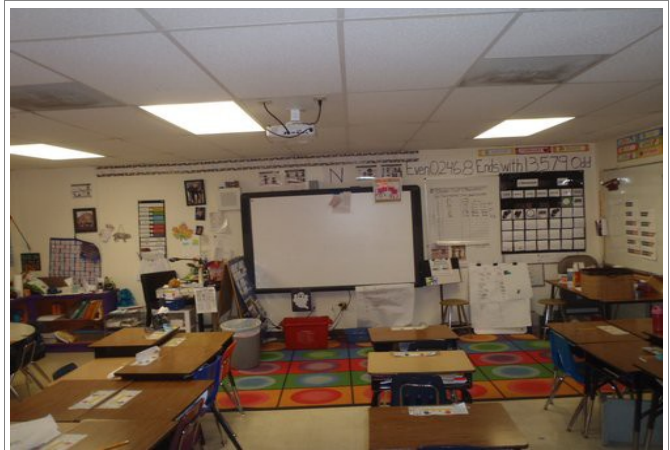
**Photo #113**

Testing Conditions - Building Occupied During Test
