Radon Test

Pedee Campus
12975 Kings Valley Hwy
Monmouth OR 97361

Luckiamute Valley Charter Schools
12975 Kings Valley Hwy
Monmouth OR 97361

Date: 11/08/2019 File name: LV13559
Person ordering inspection: Daniel Shimek

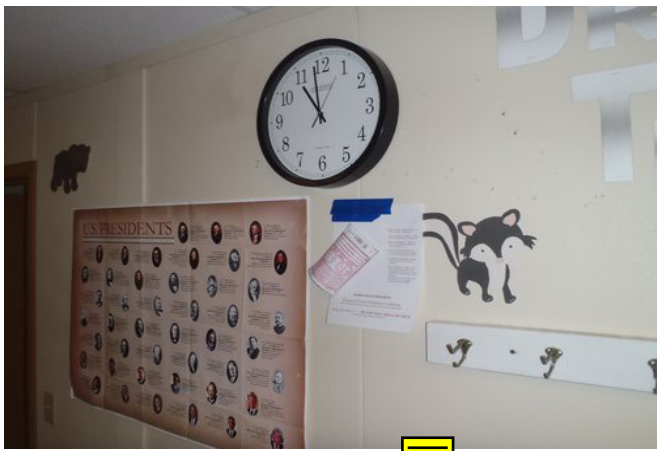
2.2 Test Location - Multiple Locations See Matrix Multiple test kits were deployed for the purpose of this test. Refer to the attached testing matrix for number of tests and location of placement information. (See Photo #100 104 110 114)

Charcoal Absorption - Radon - Test Location

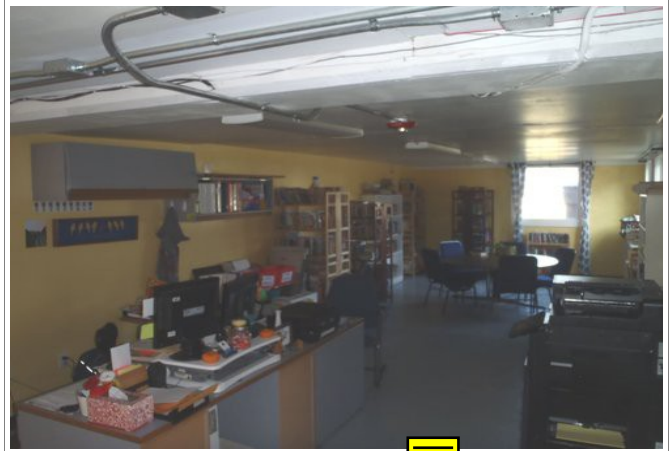
Photo #104

Charcoal Absorption - Radon - Test Location

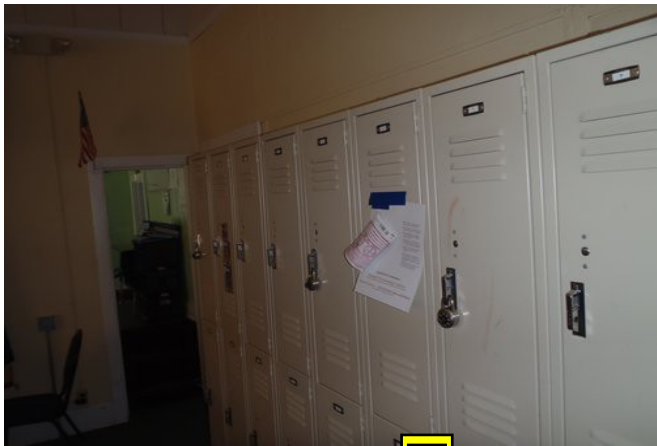
Photo #110

Charcoal Absorption - Radon - Test Location

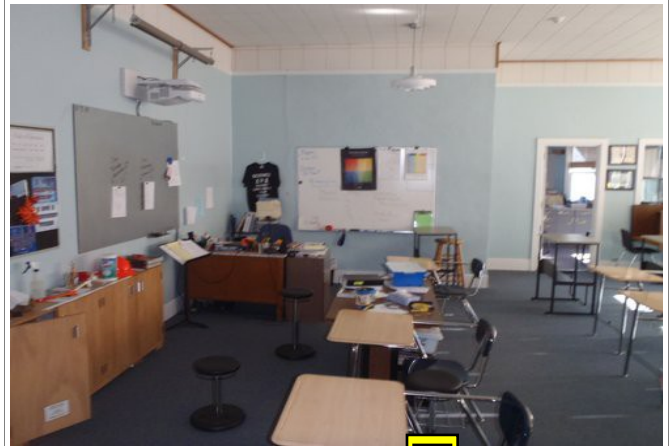
Photo #114

Charcoal Absorption - Radon - Test Location

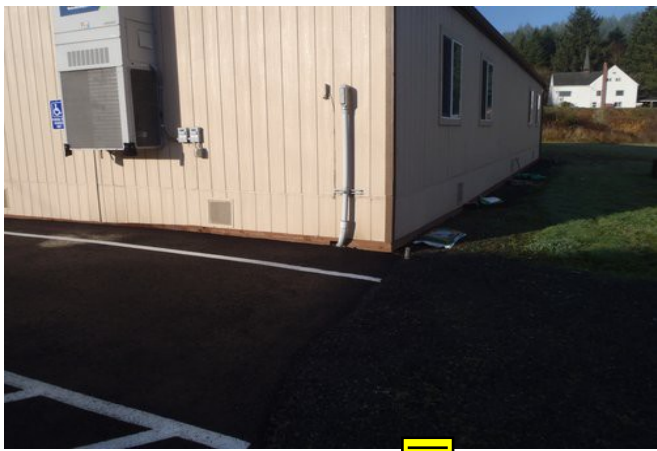
Photo #125

3.2 Foundation Type, Modular Bldgs - Modular Raised Open The structure is constructed with wood skirting around the perimeter. There is air space between the structure floors and the ground. The foundation vents were open at the start and/or end of the test; therefore, it is assumed that they were not maintained closed for the duration of the test period. (See Photo #125)

Structure Information - Foundation Type, Modular Bldgs

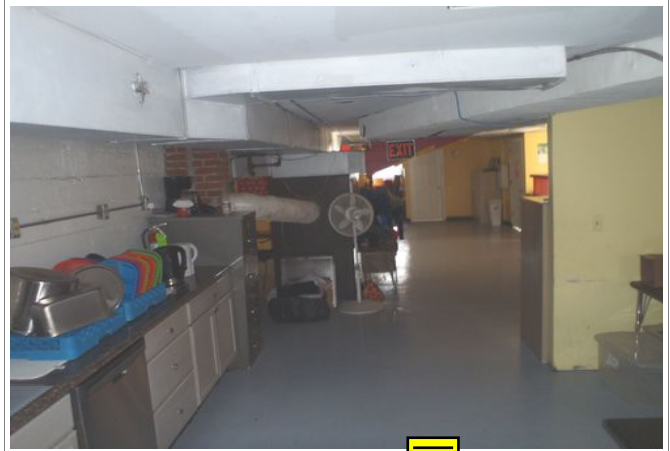
3.3 Foundation Type, Main Bldg - Basement The Main Bldg structure is constructed with an on grade concrete slab basement where all areas are built into a hillside or soil and are below ground level. (See Photo #103 123 124)

Structure Information - Foundation Type, Main Bldg

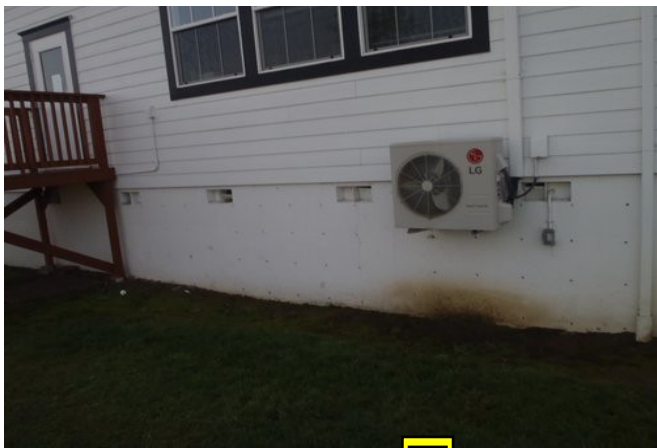
Photo #123

Structure Information - Foundation Type, Main Bldg

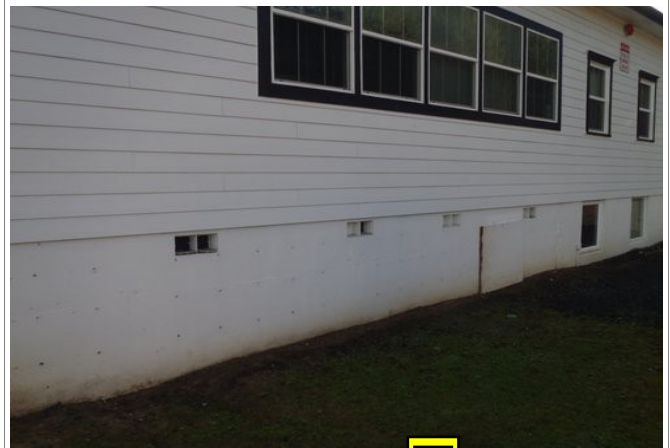
Photo #124

Structure Information - Foundation Type, Main Bldg

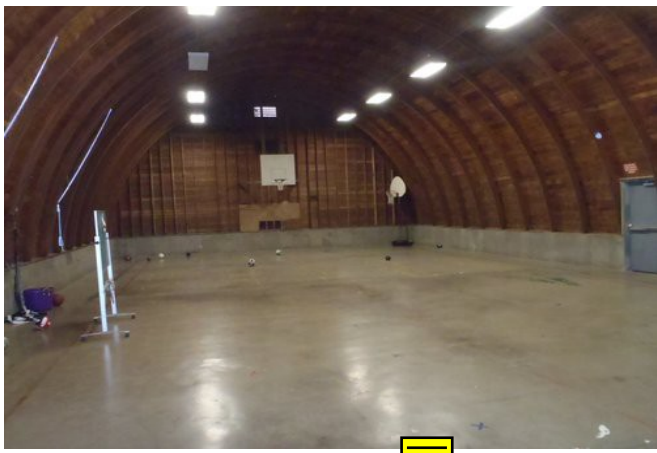
3.4 Foundation Type, Gym - Slab The gymnasium structure is constructed with a slab on grade concrete foundation that is in contact with the soil under the majority of the structure. There is no access under the structure. (See Photo #117 120)

Structure Information - Foundation Type, Gym

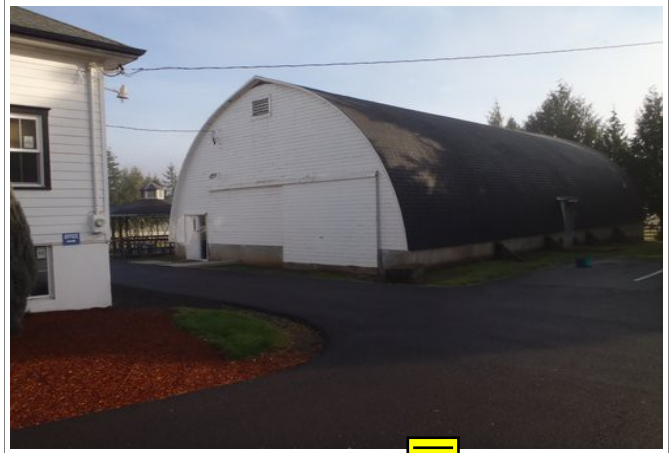
Photo #120

Structure Information - Foundation Type, Gym

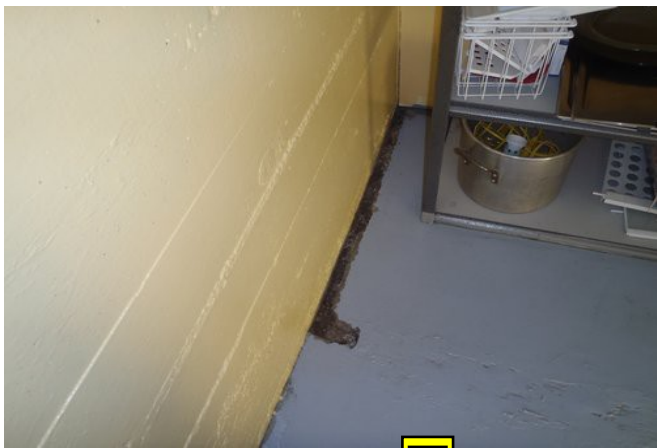
3.12 Potential Radon Entry Points - Sump Pit Repairs Recommended There is unfinished area with dirt floor and small sump pit or hole in the slab of the basement. Radon levels likely can be improved by separating exposed earth areas with special attention to air barriers and weatherstripping. Consult a qualified contractor for further evaluation and repairs to limit radon entry. (See Photo #106 107 109)

Structure Information - Potential Radon Entry Points

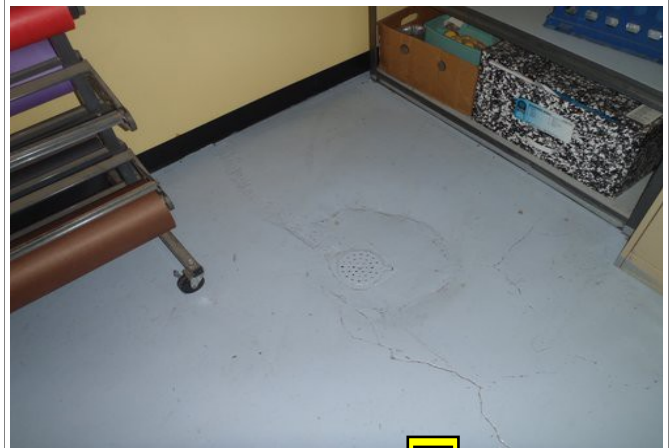
Photo #107

Structure Information - Potential Radon Entry Points

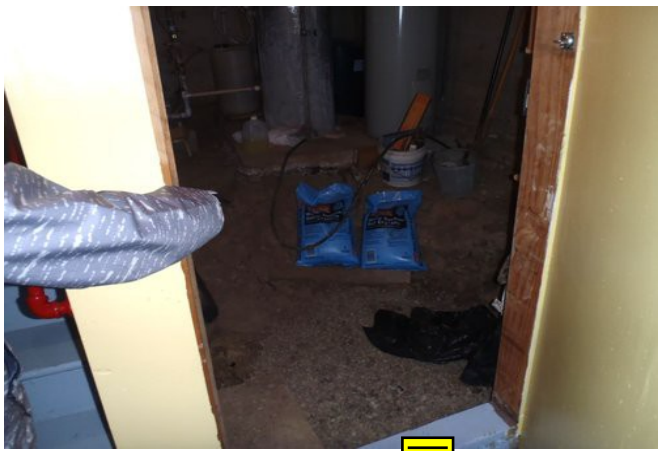
Photo #109

Structure Information - Potential Radon Entry Points
