Radon Test

Bridgeport Campus  
17475 Bridgeport Rd.  
Dallas OR 97338

Luckiamute Valley Charter Schools  
12975 Kings Valley Hwy  
Monmouth OR 97361

Date: 01/20/2020      File name: LV13560  
Person ordering inspection: Daniel Shimek

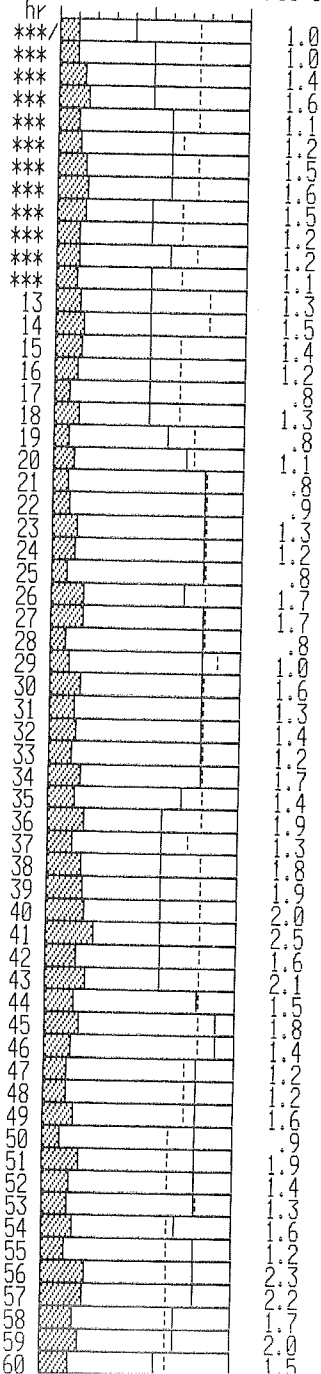
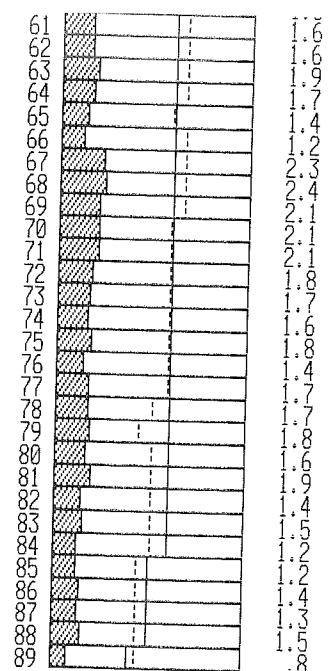
SERIAL NO. - CRM5105512  
 C/F (CPM/pCi/l) .377  
 BK/G (pCi/l) .3

Elapsed Time (min.) 4620  
 Total Count 3282  
 Avg. (pCi/l) 1.5

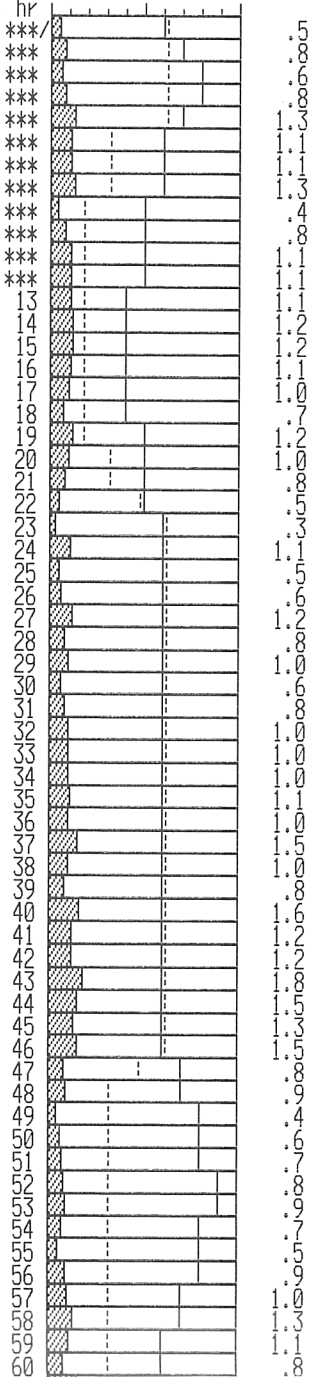
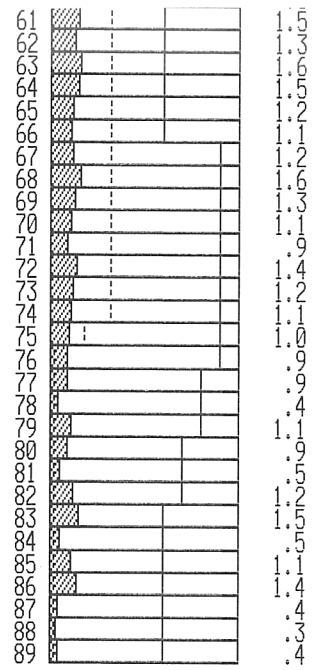
SERIAL NO. - CRM5106066  
 C/F (CPM/pCi/l) .380  
 BKG (pCi/l) .6

Elapsed Time (min.) 4620  
 Total Count 2894  
 Avg. (pCi/l) 1.0

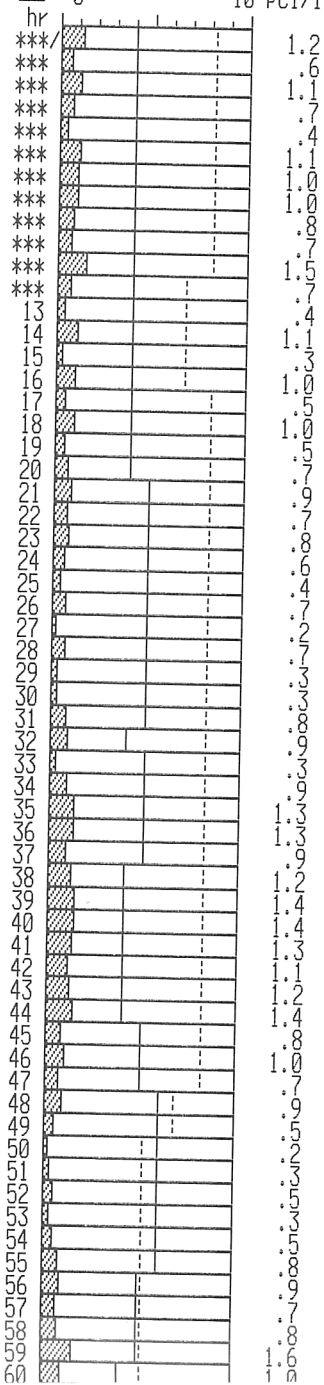
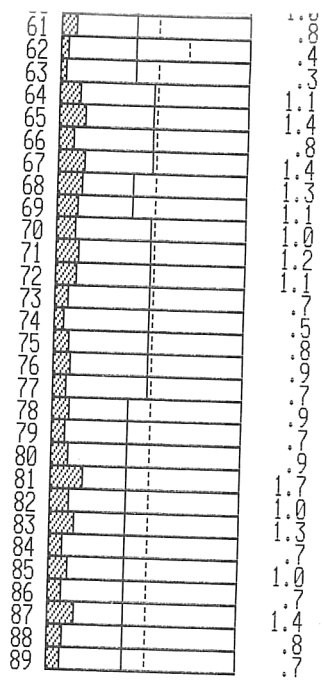
SERIAL NO. - CRM5106326  
 C/F (CPM/PCi/l) .353  
 BKG (PCi/l) .5

Elapsed Time (min.) 4620  
 Total Count 2287  
 Avg. (PCi/l) .9
